MOTOROLA
Semiconductor Products Sector

Order Number: MCF5307UMAD/D
Rev. 0, 1/2001

Errata to ***MCF5307 ColdFire® Microprocessor User's Manual***

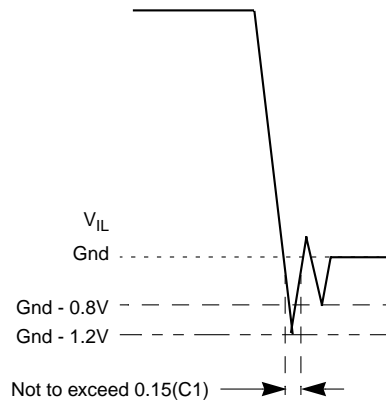
Figure 1. Undershoot Voltage

11.4.2, 11-18	<p>Add the following text:</p> <p>NOTE: Glitches may occur on the address lines unless EDGESEL is tied high or BCLKO is qualified with the assertion of $\overline{\text{SRAS}}$ or $\overline{\text{SCAS}}$ before connecting to the EDGESEL input. These glitches do not affect DRAM controller operation and are within the undershoot limits specified by Figure 1 of this document.</p>

Section #/Page #	Changes
12.5.2.1, 12-13	Add the following text: NOTE: Use the CPU to write to the UART transmitter buffer. The DMA module is not able to properly transfer information from memory to the UART.
12.5.2.2, 12-13	Add the following text: Do not use single address access mode in cycle-steal mode; errant accesses may occur.
18.9, 18-23	Add the following text: NOTE: Either do not allow external master access to SDRAM using the MCF5307 DRAM controller or provide external termination for SDRAM bus cycles by an external master. The MCF5307 does not provide correct termination for external bus masters using the on-chip SDRAM controller.
20.1 20-2	Add the following diagram and text: Figure 1 shows the allowable undershoot voltage on the MCF5307. Note that 1.2-V undershoot is only allowable if it is present 1% or less of the total processor operating time.
